Manhole Inspection Summary

Manhole # S45MM_035MH

Insp Date: **3/24/08 1:56 PM**

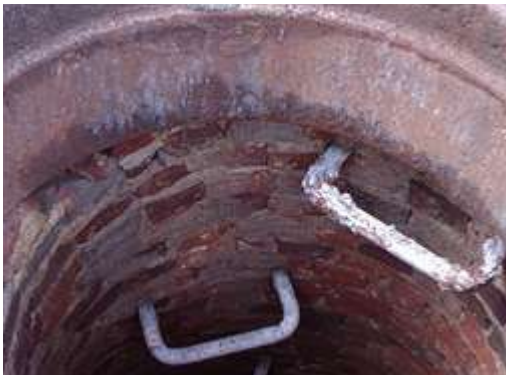
Defect 1

Condition: ☐ Sound ☐ Cracked ☐ Root Intrusion ☒ **Loose Brick** ☐ Deteriorated

Infiltration: ☐ None ☐ Joint ☐ Cracks ☒ **Mortar** ☐ Roots ☒ **Wall**

adjustment joint

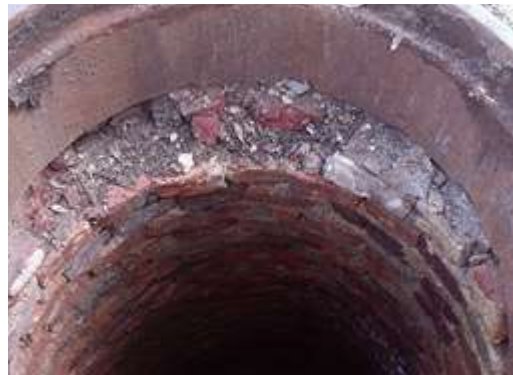
Defect 2

Frame Offset: **5** (in.) Condition: ☐ Sound ☐ Cracked ☒ **Leaks**

offset

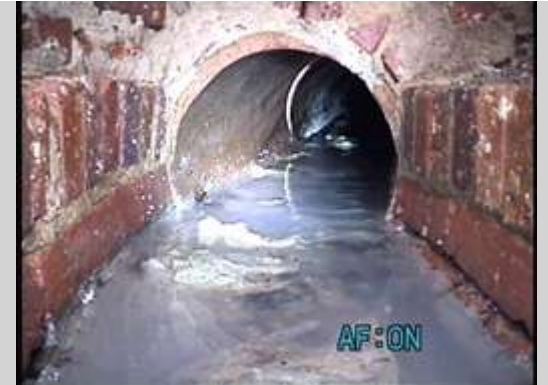
12 O'Clock Outflow

12 in. Circular Gravity Sewer
Pipe Out @ 12 O'Clock

Pipe Height: **12** (in.) Rod and Bar (Angled)
Pipe Material: **Clay** ☐ Pipe Lined
Invert Depth: **10.00** (ft.) Flow Characteristics: **Slow**
Deposits: ☐ None ☒ Mud ☒ Sludge ☒ Debris ☐ Grease
Silt Depth: **2** (in.) Deposits Extent: **Light**
Infiltration: **None** Pipe Seal Cond: **Sound**

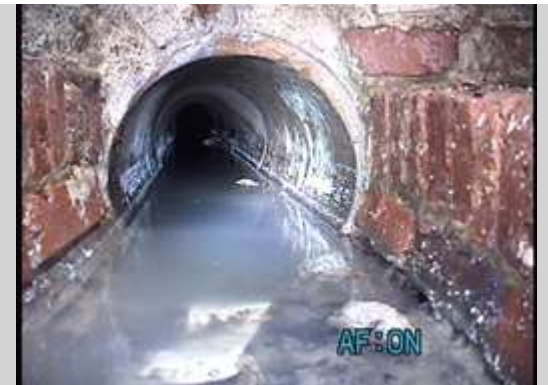
6 O'Clock Inflow

12 in. Circular Gravity Sewer
Pipe In @ 6 O'Clock

Pipe Height: **12** (in.) Rod and Bar (Angled)
Pipe Material: **Clay** ☐ Pipe Lined
Invert Depth: **9.90** (ft.) Flow Characteristics: **Fast**
Deposits: ☒ None ☐ Mud ☐ Sludge ☐ Debris ☐ Grease
Silt Depth: **3** (in.) Deposits Extent: **Medium**
Infiltration: **None** Pipe Seal Cond: **Sound**
